Rectangular Rapid Flash Beacon (RRFB)

This summary is one in a series describing Innovative Intersection Safety Treatments. The summaries identify new technologies and techniques to improve intersection safety developed since NCHRP Report 500, Volumes 5 and 12, were published in 2003 and 2004, respectively. These treatments show promise for improving safety but comprehensive effectiveness evaluations are not yet available.

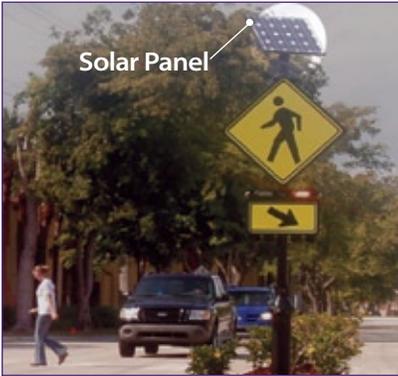
Figure 1: Activated, solar-powered RRFB on a center island at an unsignalized intersection—beacons flash using an irregular flash pattern that is similar to emergency flashers on police vehicles

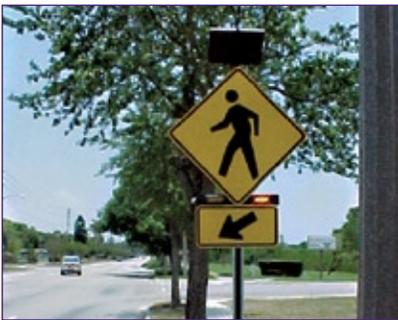
Figure 2: Activated, solar-powered, roadside RRFB at a mid-block crosswalk
